Inovyn Salt Business

High Pressure Water Jetting

Safety Awards 2019

Inovyn Salt Works, Weston Point, UK Runcorn

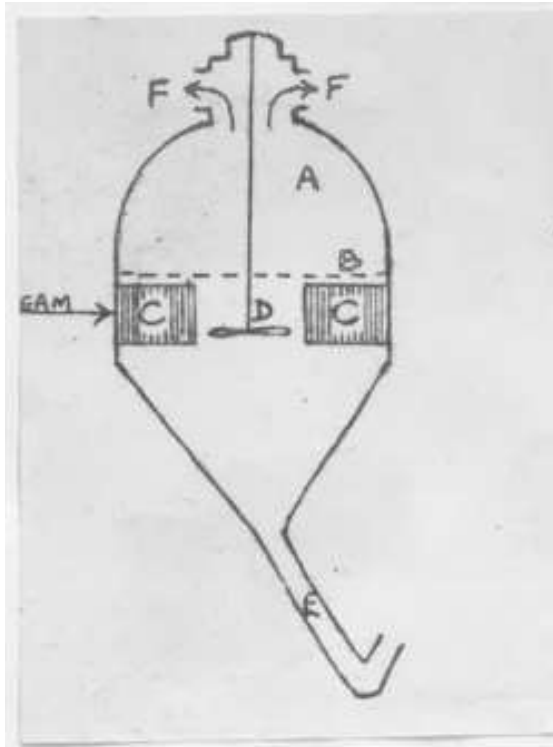
Evaporator 1911 - 1956

- Original design had internal tubes for heating the brine
- Replaced in the 1950's with external heat exchangers.
- Tubes have always required descaling from hard salt and calcium carbonate.

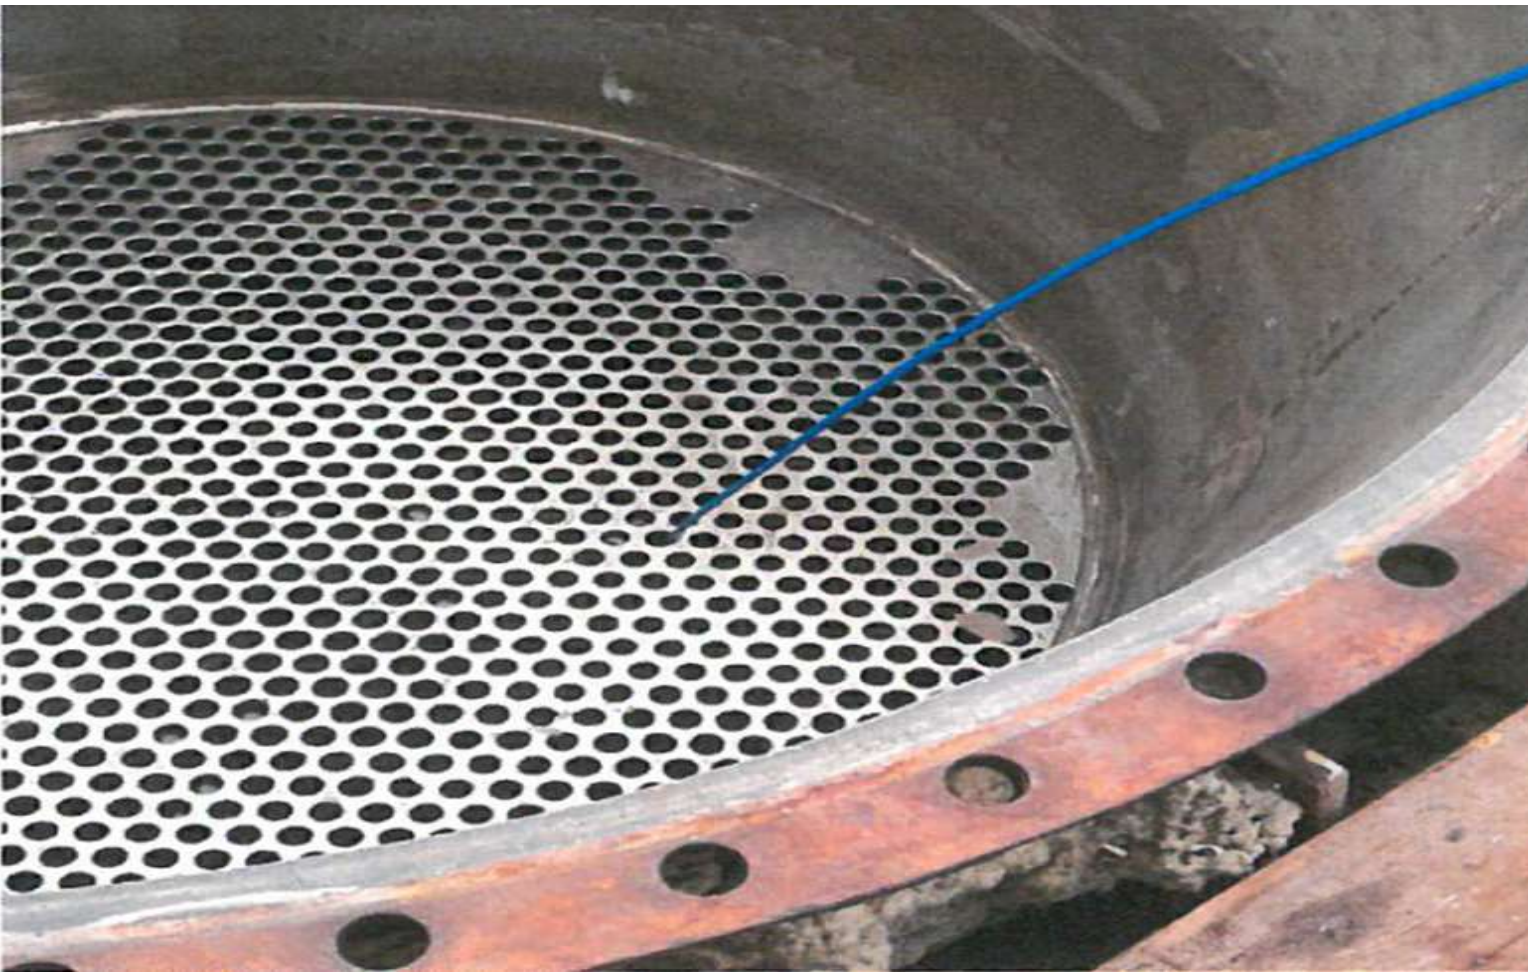
Today's Heat Exchangers

- 8 units with between 800 to 1800 tubes. Tube diameter 25mm.
- High Pressure Water Jetting @ 15,000 PSI / 1000 bar
- Hard salt in the higher temperature vessels historically tough to clear.

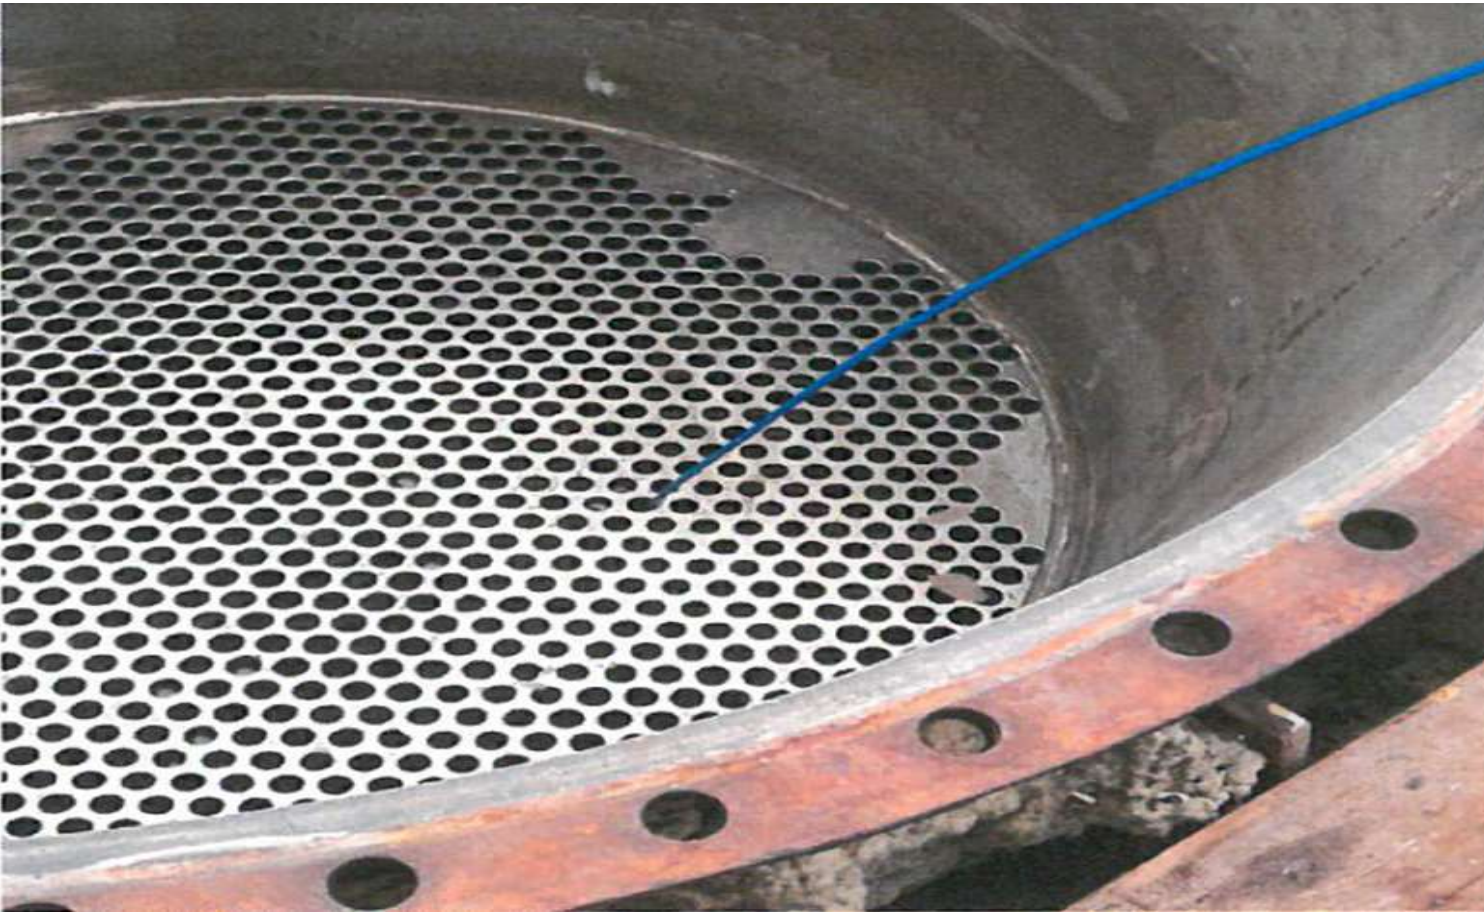
Pre 2017 Salt Site Cleaning Technology

- High Pressure Water Jetting @ 15,000 PSI / 1000 bar.
- Cleaned using a plastic high pressure water hose with a cleaning nozzle.
- Operator manually feeds the flex hose into the tubes.
- An externally operated foot pedal controls the pressure on the hose.
- Three person operation.

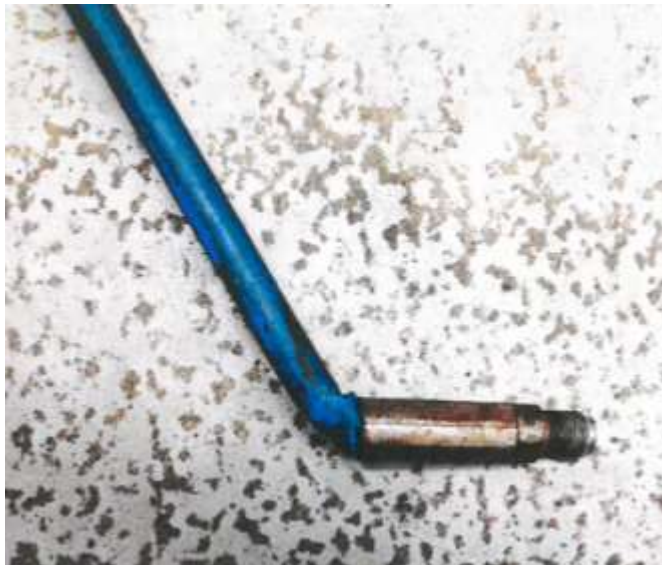
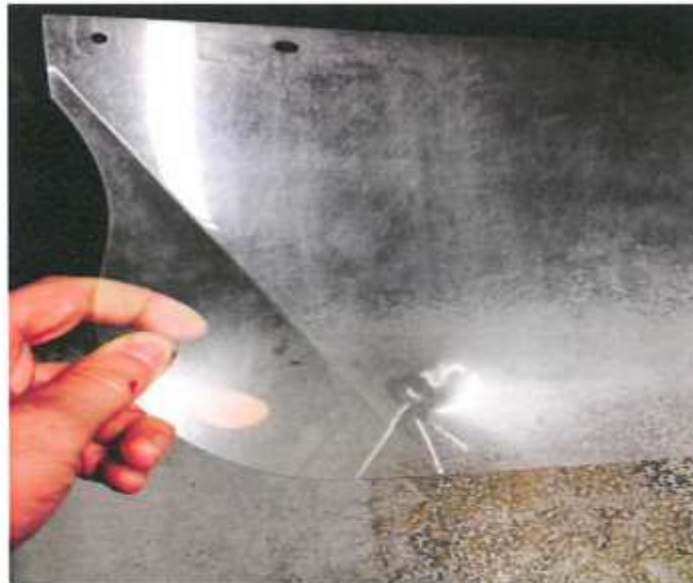
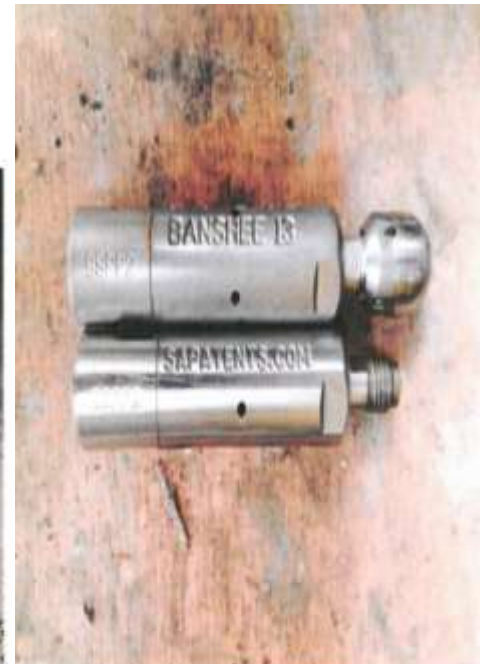
Incident at Inovyn Salt Business

- During cleaning of a tube bundle, the “banshee cutting head” detached from the hose.
- The lance was ejected back up the tube and hit the operator in the face
- Injured party sustained fractured nose.

- Anti ejection device used, that fitted over the tubes and prevented the hose / nozzle from being ejected if failure occurred.
- Implemented after the reportable injury at Salt site and forms part of safe systems of work and risk assessments for HPWJ.

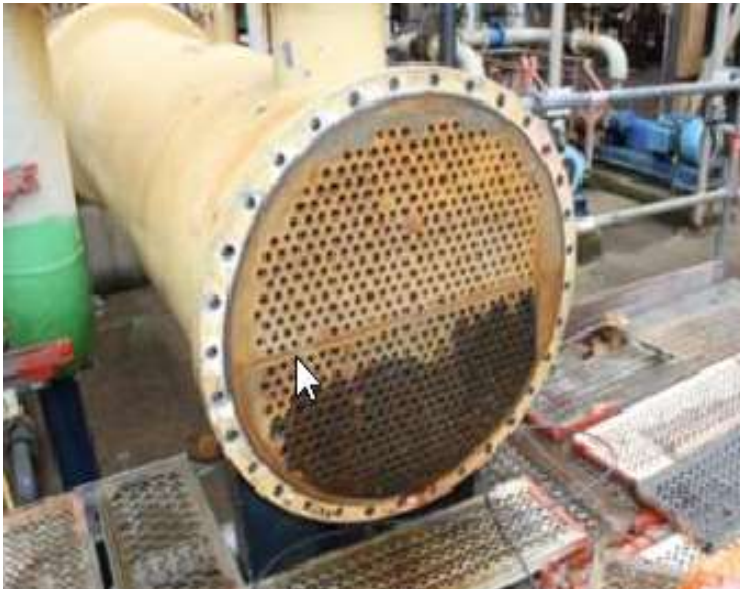
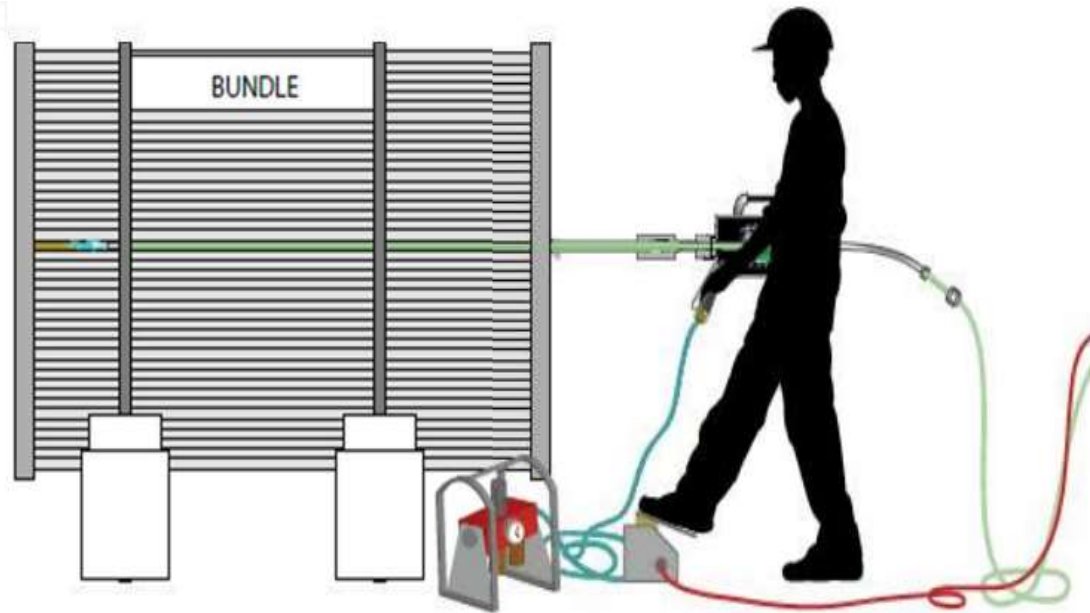
High Pressure Water Jetting Can be Fatal

- Germany March 2018
- 6m length tubes , 13mm diameter.
- 2 person operation.
- Operator 1 cleaning tubes with lance that had a rotating nozzle on the end of it. A foot pedal valve is used for stopping the high pressure water supply.
- Operator 2 is next to the machine (compressor) on the ground to shut it off in an emergency.

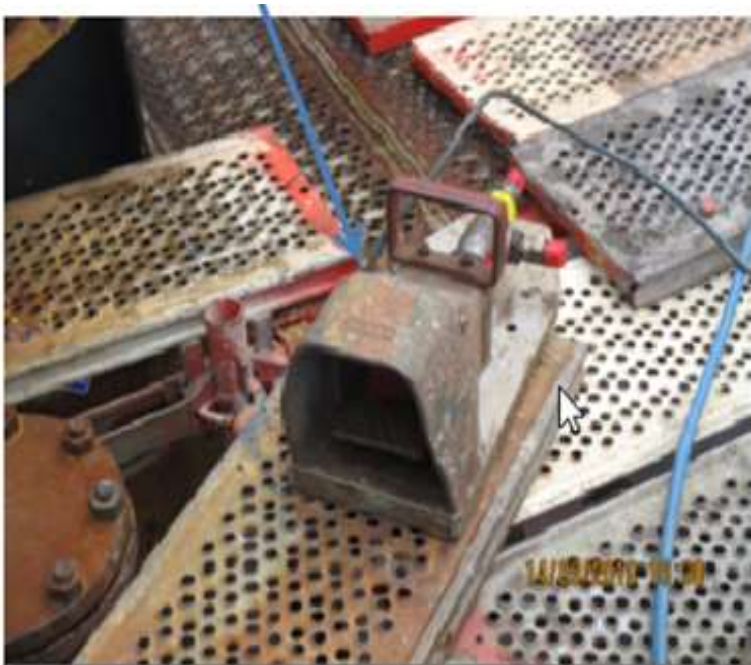
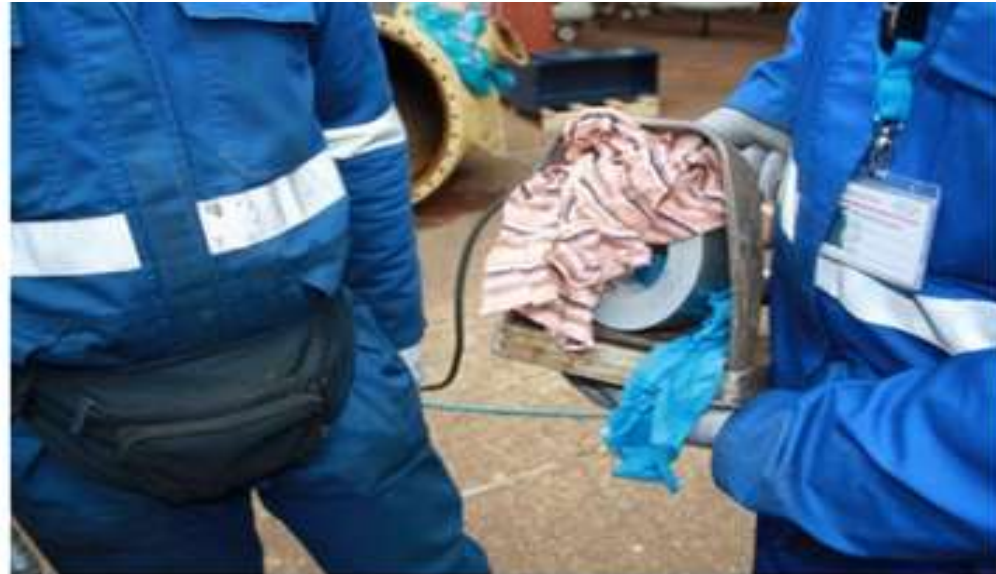
Fatal Incident (Outside INEOS) What happened

- After 2 hours of cleaning the tubes, Operator 1 was struck on the leg by the HP hose nozzle which caused severe internal injuries.
- IP tragically died at the scene.
- Operator 1 had blocked the foot pedal with rags and tape, ensuring the water would not turn off. It is suspected that after extracting the nozzle from a tube he somehow came into contact with it.
- Operator 2 was not observing the job, occupied with other work.

Figure: Demonstration of a technique that was potentially used to block foot pedal
